# Tadao Ando 4 by 4 House

## Building Physics: Lighting Report

Lighting Analysis of 4x4 House

Kobe, Japan.

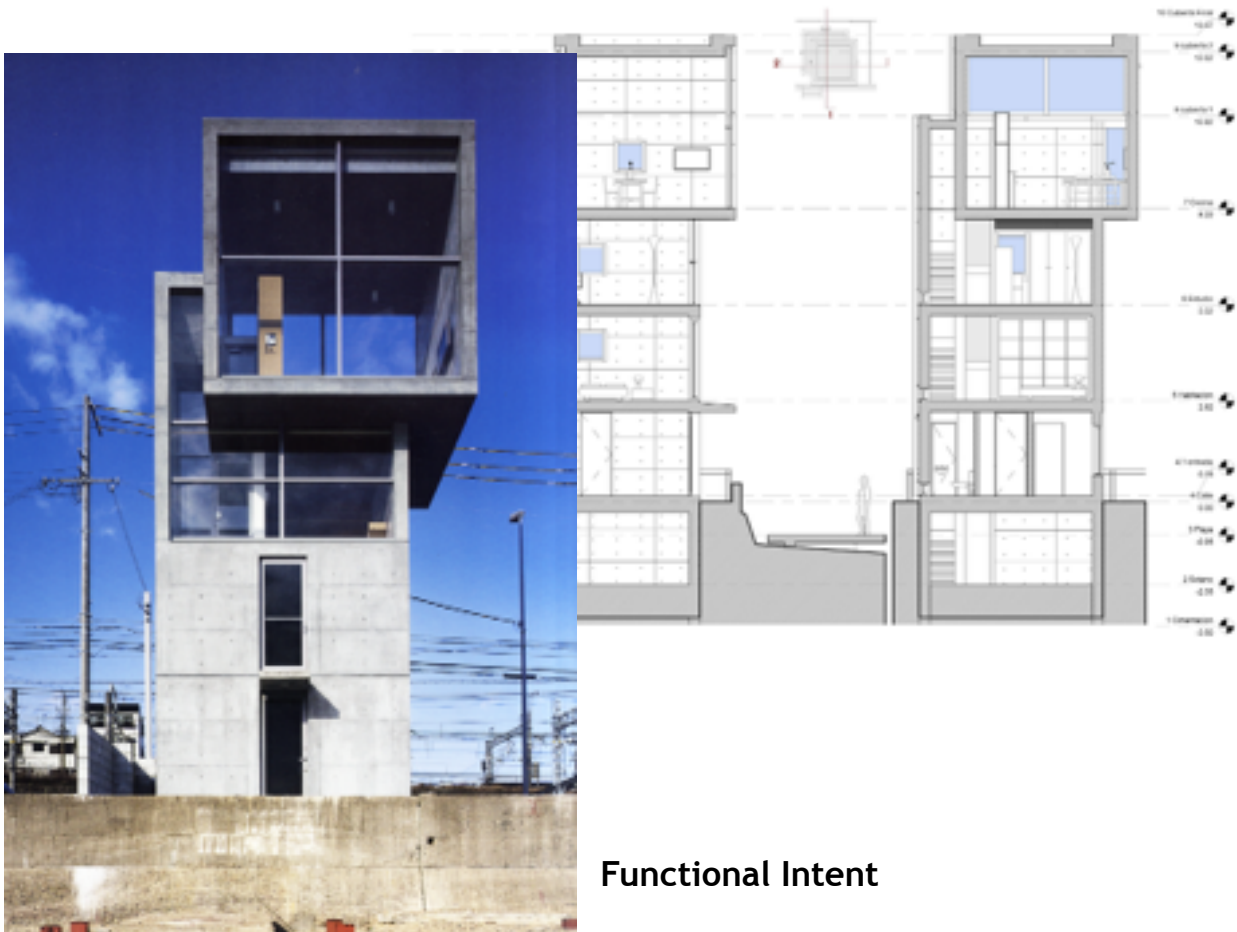
The house has four floors each programmed for a different function. The basement is used for storage, service and access on the ground floor, bedroom on the first floor, study on the second and kitchen and dining room on the top floor. All spaces are connected by the stairs which are located on the left side of the building and almost all of them are completely enclosed on three sides but the fourth floor which is opened to face towards the sea. The big windows on

the south side of the building allow sunlight to come in during the day in the kitchen and dining room and the study room. While the enclosed spaces on the basement and first floor creates a private space for the bedroom and bathroom kitchen and dining room and the study room. While the enclosed spaces on the basement and first floor creates a private space for the bedroom and bathroom.

The first two floors of the building are enclosed with slit windows for adequate lighting inside the house, while the third and fourth floor have bigger windows on the southern side that faces the sea to create a sense of openness to the house. The slit windows near the staircases ensure lighting in the day in conservation of energy, the bigger windows on the top floor create a flow of light in the house and serve as picture frames to the scenery on Awaji Island.

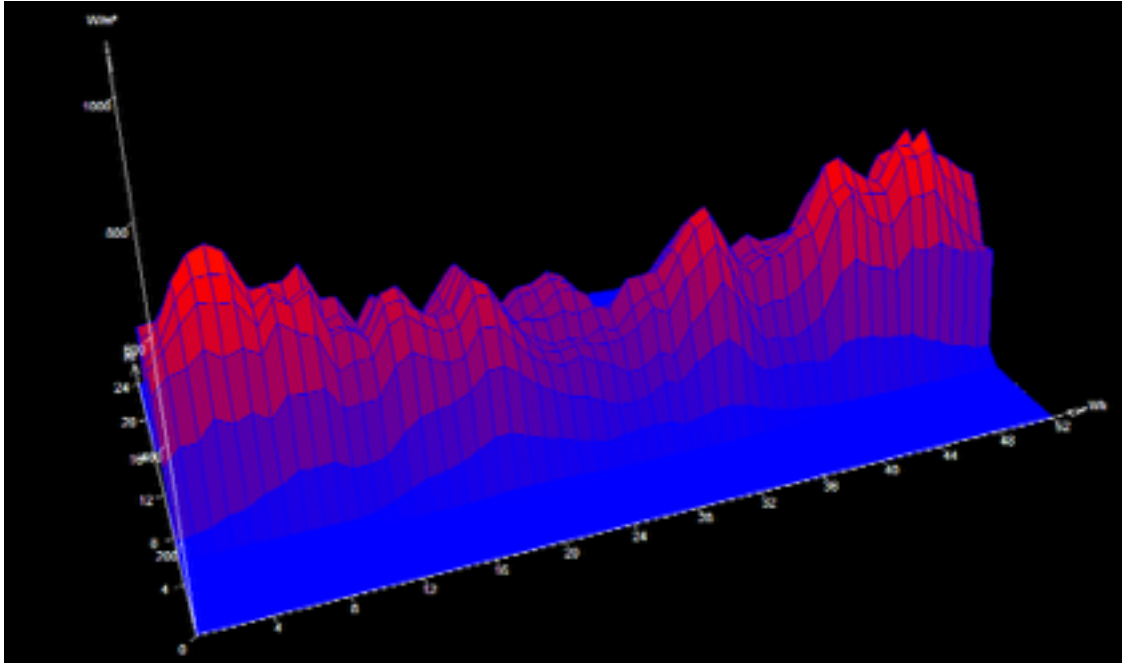
Figure #2:  
Weekly Direct  
Solar  
Radiation

The diagram shows that the site, on average, gets 11 hours of daylight every

day.

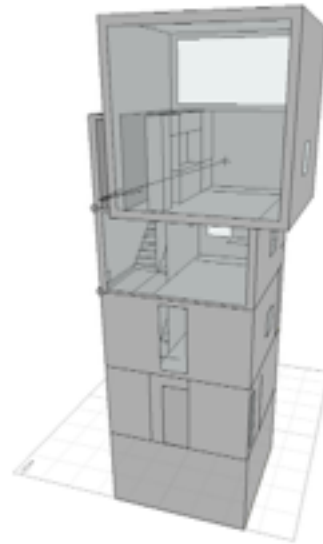
Figure #6: Average Daily Incident Solar Radiation East Wall

The solar radiation of the building is quite low from november to february (shown in the figure above) and it increases as winter ends with an average of 80 W/m<sup>2</sup> from 8:00 am to 3:00 pm.

The total monthly incident solar radiation figure was used to analyse the amount of sunlight that hits the east wall of the building throughout the months of the year. The east wall is not the one that receives most sunlight according to the sun path figure (seen below) but we also chose to analyse it considering that that's where the main function of the room is. The figure above shows how the solar radiation on the east wall decreases during winter (Nov - February) and increases through summer.

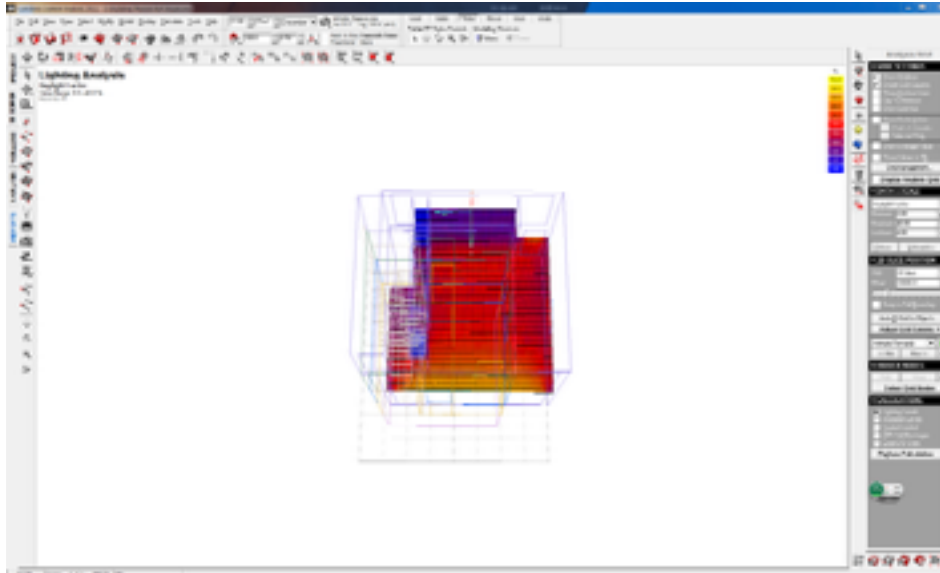
Figure #16: Grid Analysis Plan View-40%

The plan view above showed more clearly how the sunlight does not hit the staircase area and the back area of the building which is further away.

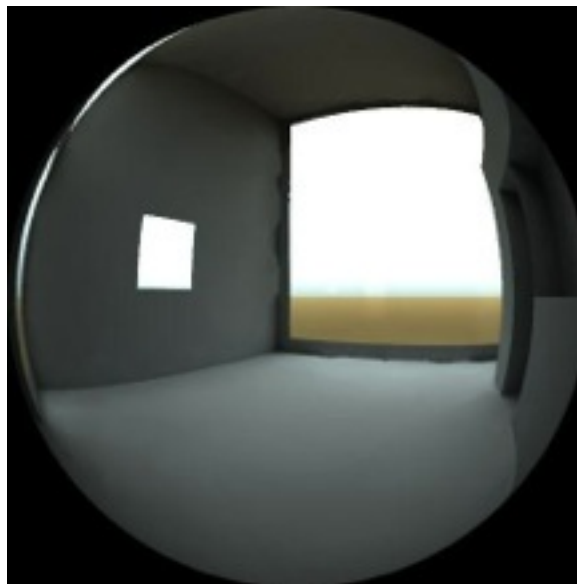
Figure #23: Luminance rendering

In our calculation, we kept getting results of UGR 0, VCP 100. We tried adjusting camera angles, adjusting different parameters, but the problem still remained. Further exploration showed that the algorithm of the glarendx simulation automatically sets a threshold of 7 times the average luminance level. Anything above 7 times the average will be considered glare. (Refer to <http://radsite.lbl.gov/radiance/refer/Notes/glare.html>) Changing the threshold when calculating, we found that threshold value from 1000 to 12000 resulted in plausible values, while which ones are accurate is debatable.
